# Lessons Learned Designing a Spherical Satellite Release Mechanism

## Abstract

A low-cost mechanism, part of the CAPE ICU payload, was designed to contain and deploy two spherical satellites from the Shuttle in December 2006. Overall the system successfully placed the satellites into orbit but encountered an anomaly. This flight anomaly and subsequent investigation revealed several key design issues. This paper discusses the lessons learned from the inaugural mission.

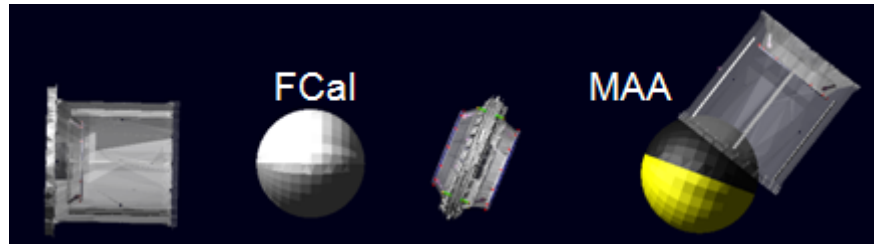
The ICU was designed to separate from the CAPE by means of actuating the NEA operated CSS Lightband. 32 compression springs on the CSS eject the ICU at a velocity of 0.52 m/s from the Shuttle. After 40 seconds, the timer in the Avionics Deck sends a signal to simultaneously separate ISS #1 and ISS #2, releasing the satellites from their respective cylinders. See Figure 7.

Figure 7. Anticipated ICU Separation Event

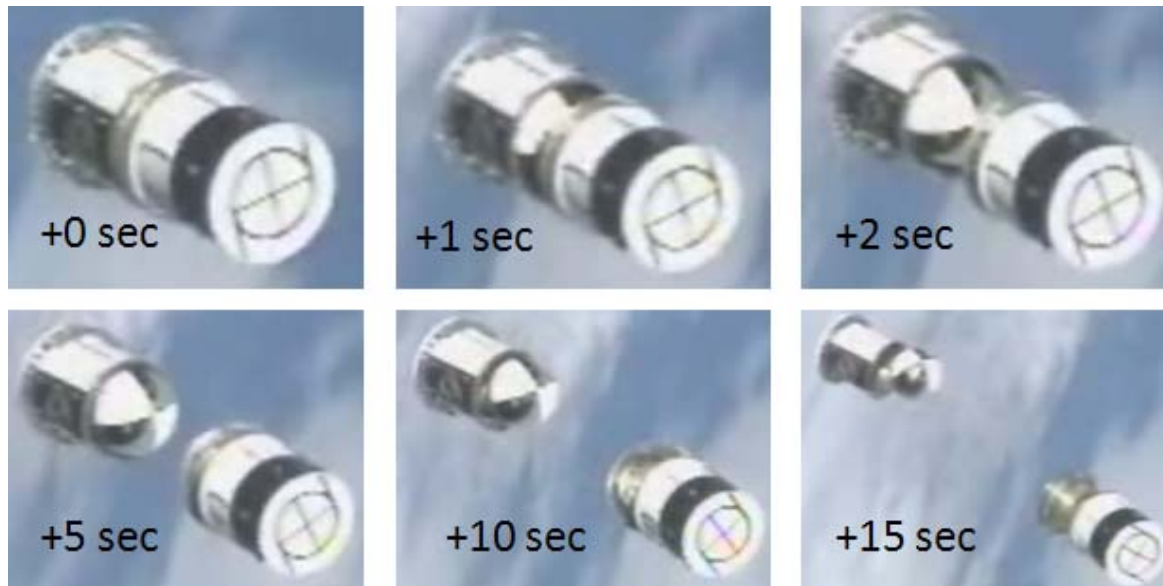
The ISS separation event had an anomaly. The satellites did not simultaneously eject from their respective cylinders as expected. FCal separated from its cylinder. Its ejection rate was as expected except when the equator reached the end of the cylinder it temporarily “stopped” for a few seconds and then slowly continued out of the cylinder. The MAA did not come out of its cylinder. Instead of all bodies ejecting simultaneously away from the central Avionics Deck, the Avionics Deck “stuck” to the cylinder for a few seconds before slowly tumbling away. The Avionics Deck showed a noticeable rotation rate of 10-15 deg/sec while the MAA Cylinder had no observable rotation. MAA was not seen to eject for the entire 20 minutes that Shuttle video tracked the MAA Cylinder. Ground operations confirmed that MAA did finally eject approximately 1 hour after ISS separation. See Figure 8.

Figure 8. Actual On-Orbit ICU Separation Event

Closer look at the flight video showed slight shadow movement of ISS #2 (MAA Lightband) one frame before ISS #1 movement was noticed. The theory was that when ISS #1 separated it pushed the Avionics Deck back against the MAA Cylinder causing the halves of ISS #2 to temporarily contact. Eventually it was believed that one of the roller separation springs on the Avionics Deck re-contacted MAA. This imparted a torque on the Avionics Deck, but since the spring force's line of action bisects the center of MAA, the MAA/Cylinder received very little torque. This explains why the Avionics Deck spun-up and the MAA Cylinder did not.

Using dynamic simulation software, Matthew Eby of The Aerospace Corporation was able to model many variations of the separation event. This included simultaneous ISS separation and staggers of varying delay. He also adjusted the o-ring preload. In the end, the analysis confirmed the initial assumptions that ISS #2 separated 0.01 to 0.02 seconds before ISS #1. The halves of ISS #2 temporarily re-contacted and a roller separation spring re-contacted MAA, imparting the observed rotation on the Avionics Deck.

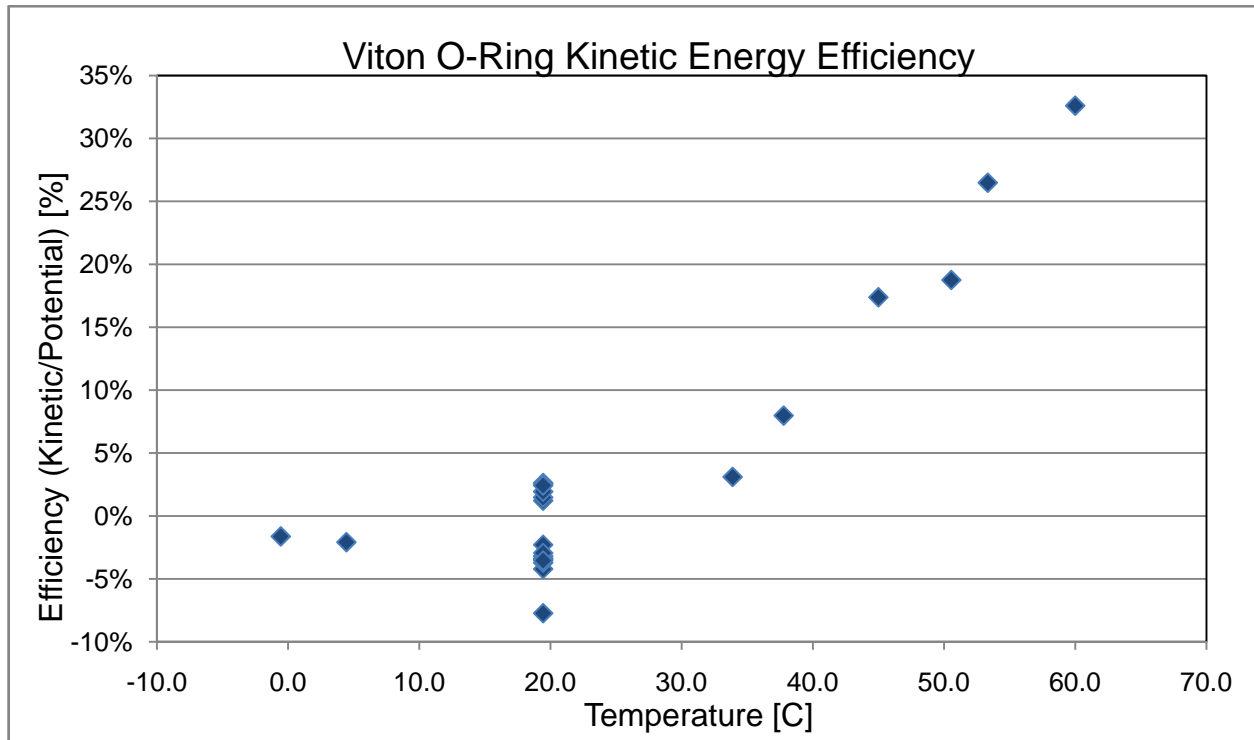
Since the flight, testing has been performed to determine the energy ratio of Viton as a function of temperature. A 380mm diameter Lightband separation system was separated on a 5 degree-of-freedom air bearing fixture to obtain a baseline velocity. A 7mm thick, 180mm OD o-ring was then placed inside the Lightband and compressed to a known preload and distance. The Lightband was again separated and velocity measured. The change in kinetic energy due to the o-ring could then be calculated. The results can be seen in Figure 10.

**Figure 10. Ratio of Imparted Kinetic Energy to Stored Compression Energy in a Viton O-Ring**

Several trials at various compressions were performed at room temperature, while only a few trials were performed hot and cold. This explains the scatter at room temperature and very little scatter elsewhere. However, from the data it is apparent that the energy efficiency of the o-ring increases with temperature. It was actually negative for some tests. The assumption is stiction between the Viton and aluminum rings decreased velocity. The test set-up and fixture limited the minimum achievable o-ring temperature to 0°C. It is still unknown how the o-ring would react at -25°C. If it follows the same trend however, it is likely that the preloaded o-rings had little effect on the separation event.

- Ensure the material properties, specifically stored energy, of an elastomeric o-ring are fully understood across the entire temperature range.
- Increase the velocity of the ICU from the CAPE. This increases the energy available to impart on the satellite ejection event.

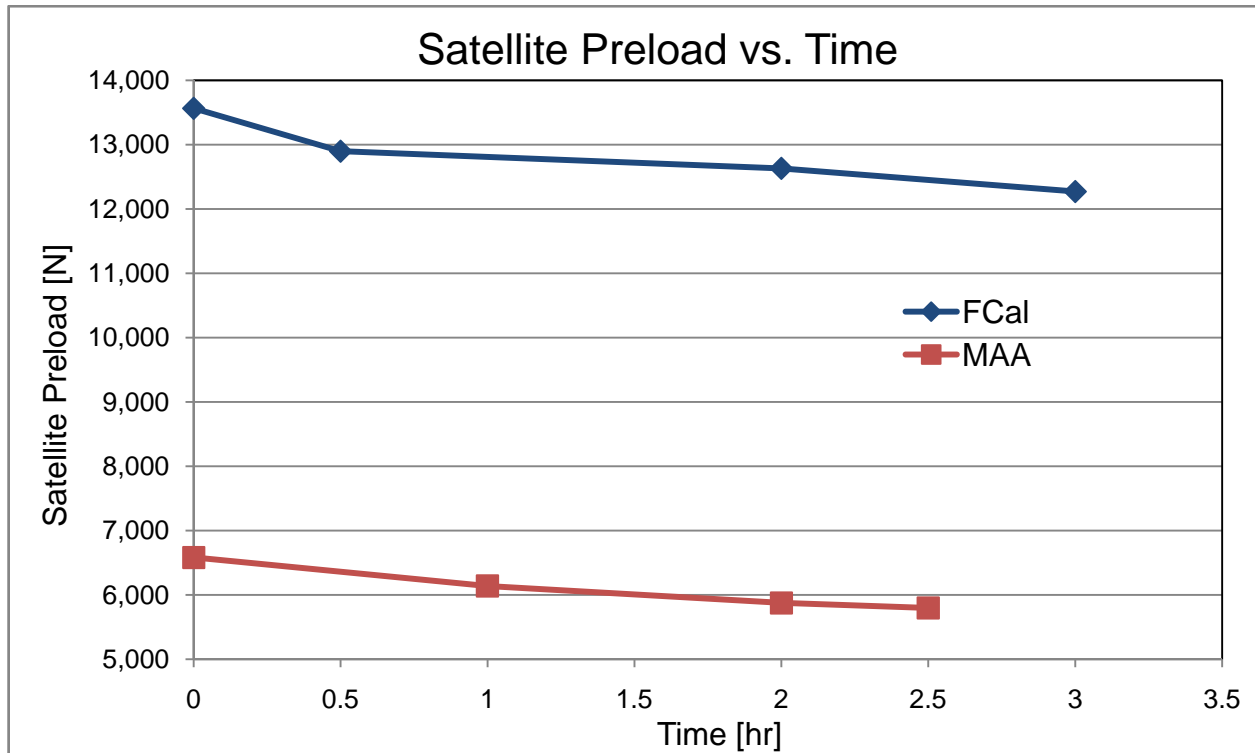
The other question that remained was the exact preload on the satellites at separation. Strain gages were bonded to the inside cylinder walls, transforming them into load cells. To keep them away from the satellites the strain gages were placed approximately 13 cm from the ends of the cylinders. These were calibrated by loading mock-up plates that simulated the interface of the satellites to the pedestals. Schedule and budget restraints prevented testing to correlate preload with respect to temperature. It also prevented the monitoring of preload over time to correlate creep in the o-rings and create a model to predict preload vs. time. The only data available was during a trial satellite installation where the satellites remained in the ICU for a few hours. See Figure 11.

**Figure 11. Decrease in Satellite Preload as a Result of O-Ring Creep**

This short timeframe makes it difficult to predict whether the preload would continue dropping or eventually approach some asymptote.

The indicated preload readings were also subject to some skepticism due to the extremely low strain in the cylinders. Given the cylinders were 490mm in diameter and 2.9mm thick, the strain was on the order of  $2E-5$  to  $4E-5$ . The indicator could measure this strain. The problem arose in bolting components together. Small variations in flatness often created localized stress increases that significantly changed the indicated preload. For instance, simply bolting the ICU Lid to the FCal Cylinder changed the indicated reading on FCal by 17,000 N. Because of this, care was taken to calibrate the load cells with everything fastened as in flight. However, the addition of preload shims could easily change the local flatness. With it being that sensitive, the preload on the satellites has a large tolerance. An improvement would be to put the strain gages on the outside of the cylinders so that they can be placed in the middle, as far away as possible from any localized interface stresses. Also, the flatness of all adjoining planes should be held as tight as reasonably possible.

- Remove the penetrating conical snubbers from the satellites. They needlessly complicate the separation event.
- Perform tests to confidently predict the preload creep on the satellites over several months.
